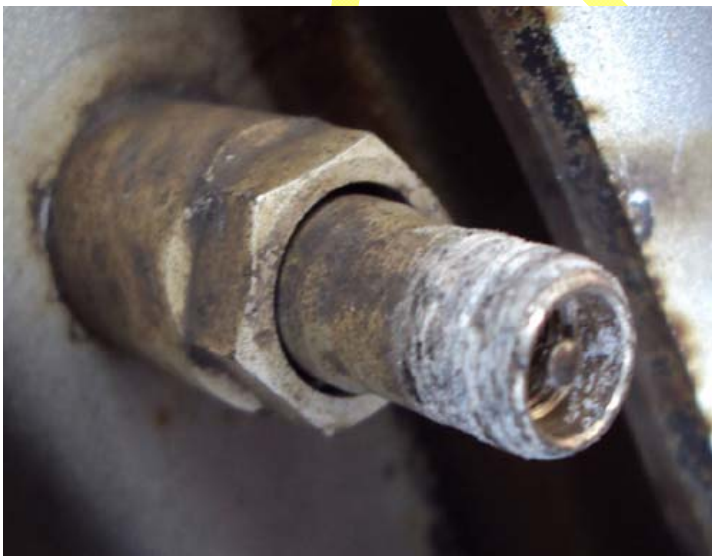
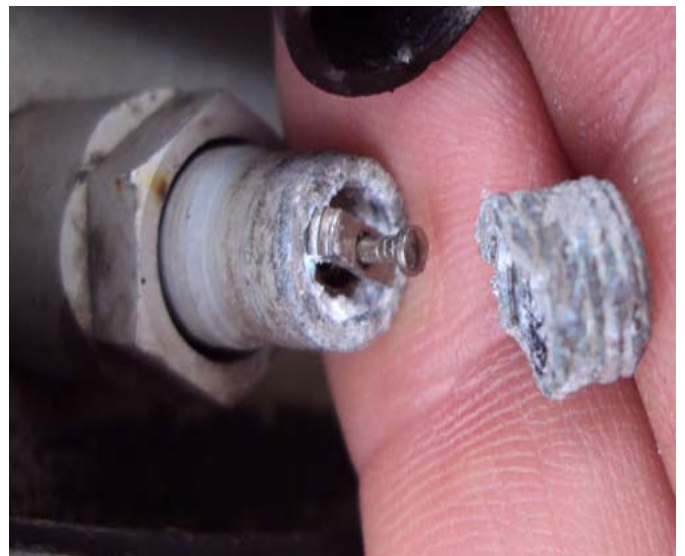
Due to a number of recent TPMS failures, please ensure all vehicles with these installed, regardless of manufacture, are inspected carefully and replaced as necessary. The pictures below show corrosion that has resulted in a failure.

One way to limit the speed of corrosion is to remove any metallic valve caps and replace with plastic. This will reduce the chance of the stem fracturing when a driver is adding/filling tires away from a Transervice facility. Please verify with your local dealer if any warranty remains on any units experiencing a problem or failure.
